Roof Condition Inspection

October 3, 2016

Current Roof Condition: Poor

Replacement Recommended: Repair-Apply Coating

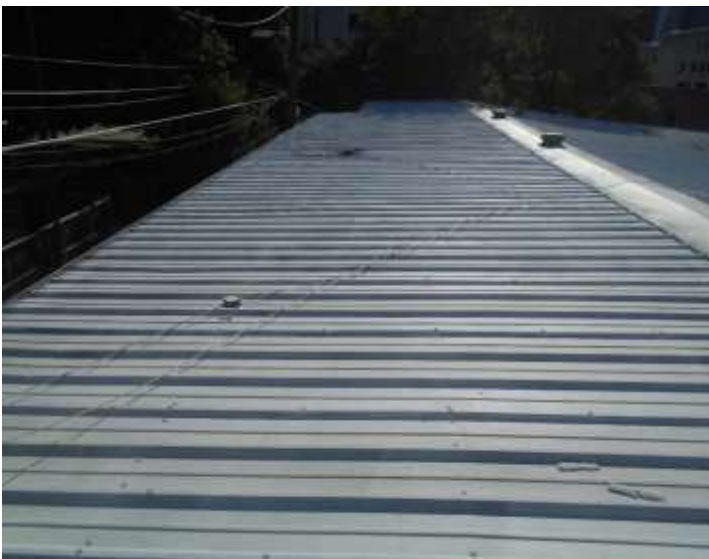
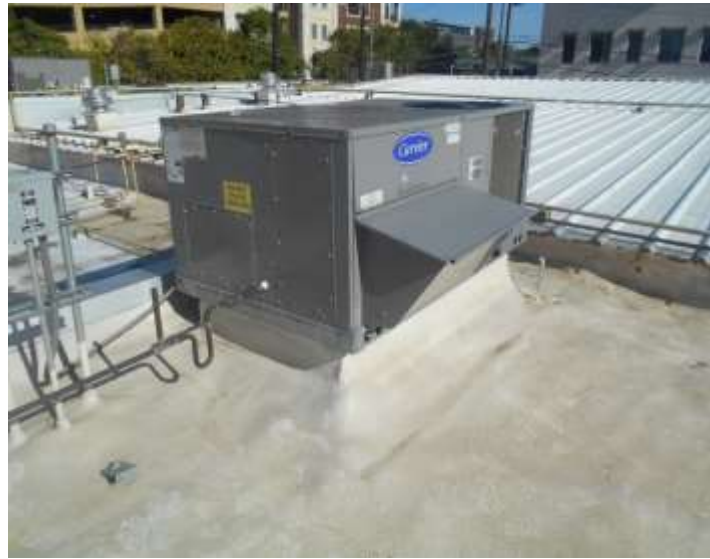
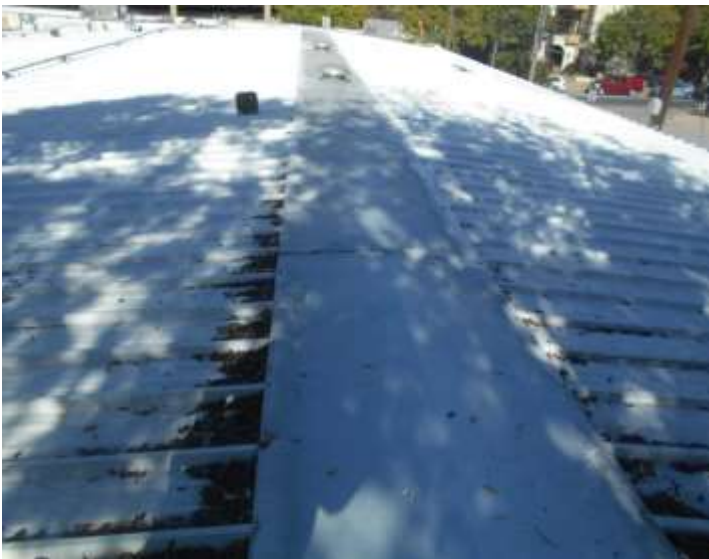
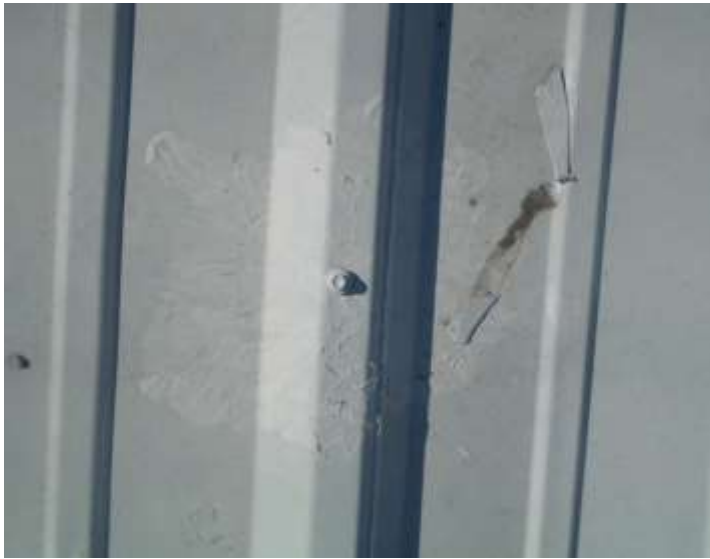
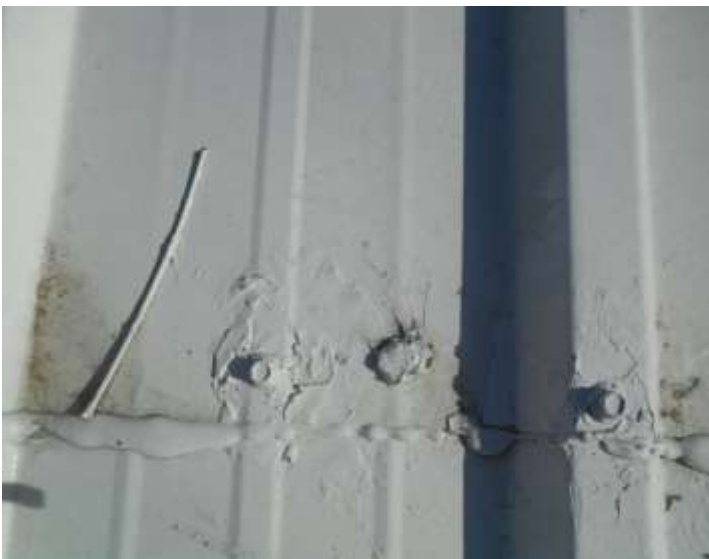
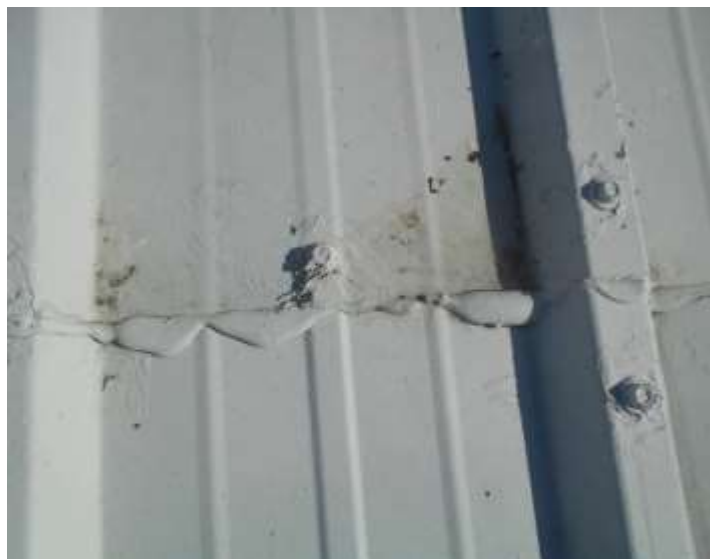
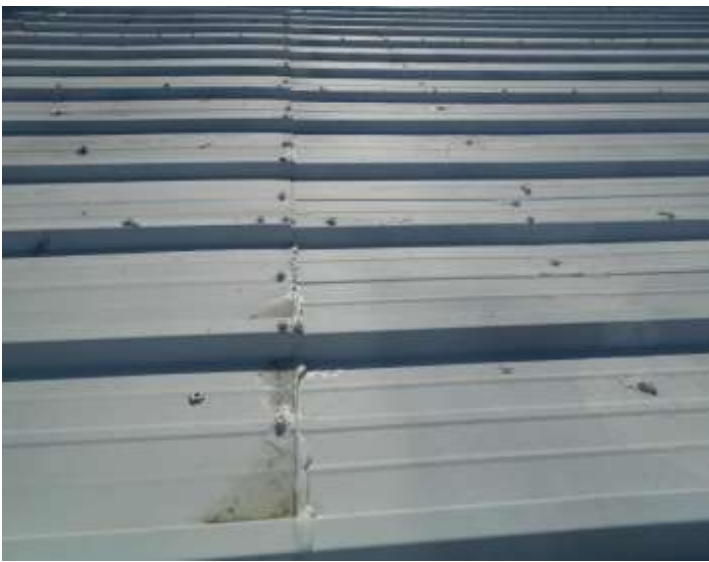
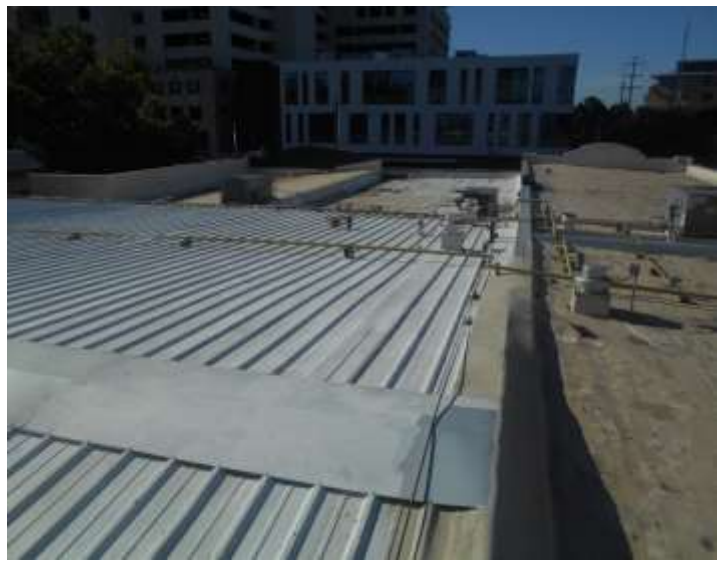
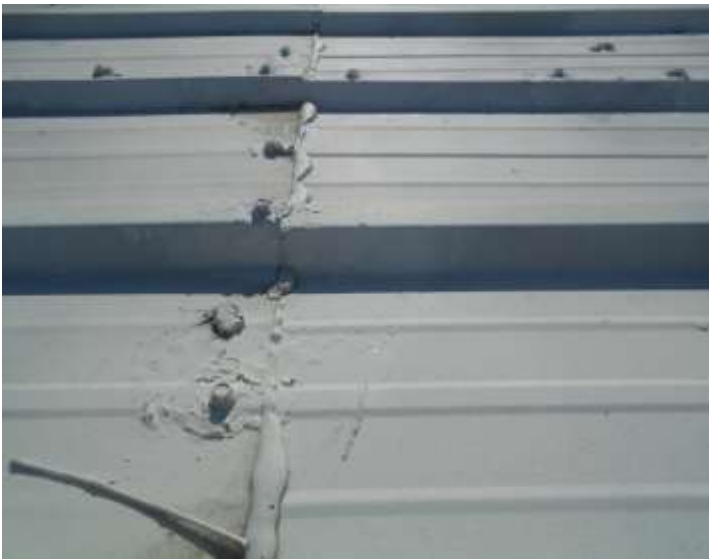
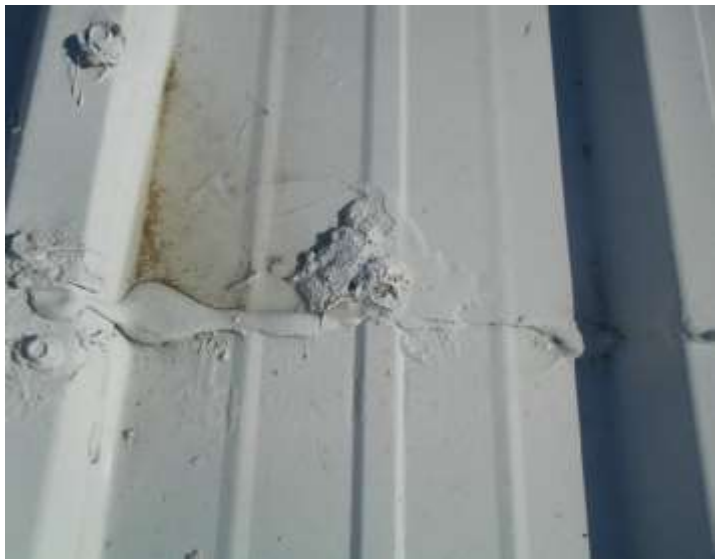
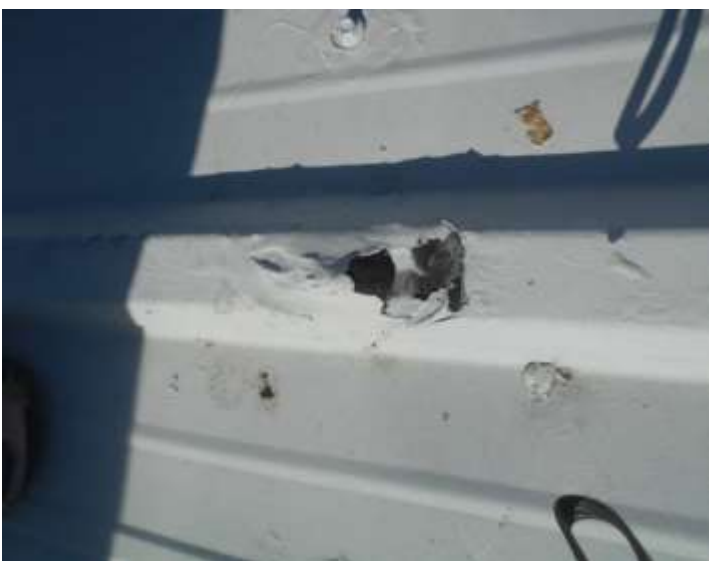
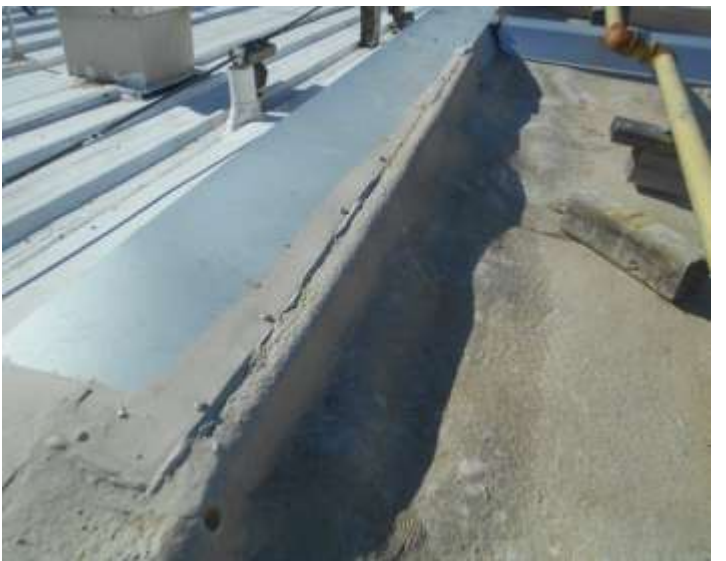
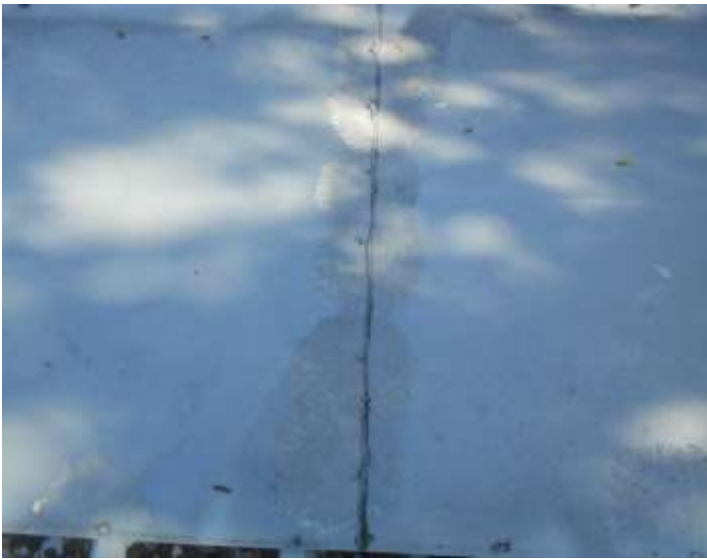
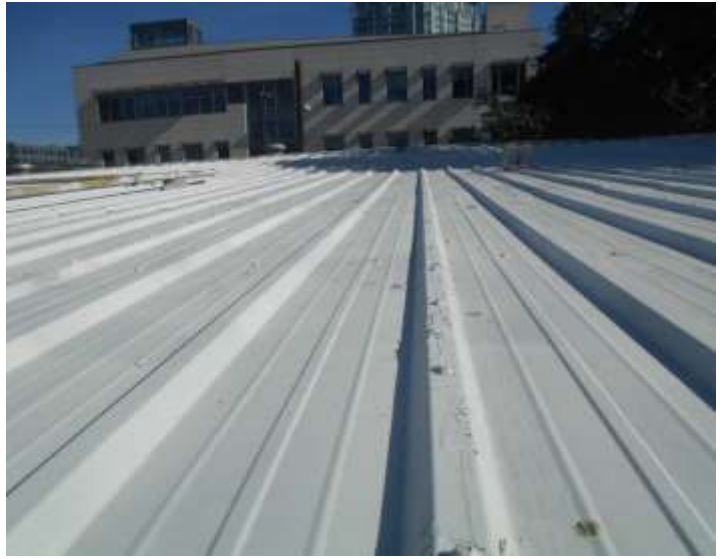
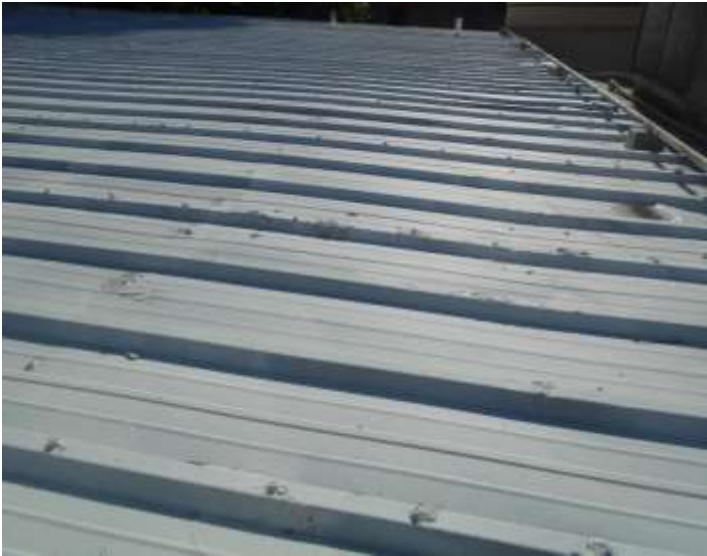
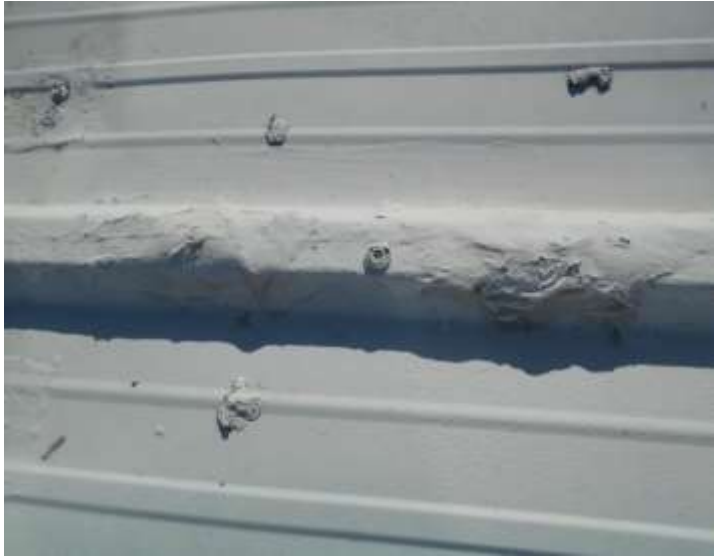
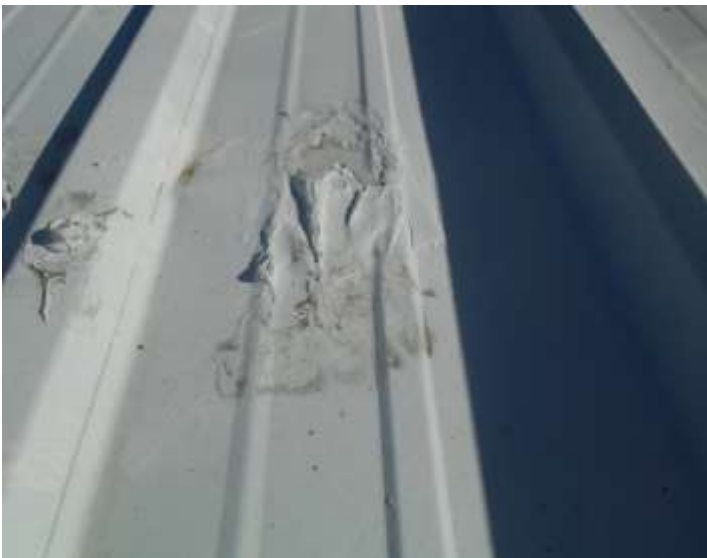
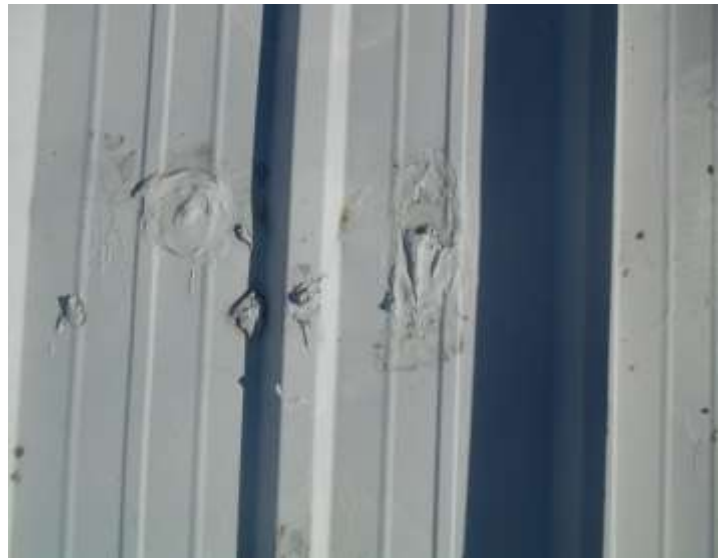
See pictures of deficiencies pages 3-5 - Metal Roof Area

Roof galvanization is effectively gone and superficial surface rust is widespread under an acrylic roof coating. The coating was either watered down or of extremely low grade (not a commercial brand). It appears to be about 3-5 years old and was not applied per industry nor manufacturer standards. Roof section was observed to be in poor overall condition with immediate repairs required.

*Prep and patch entire roof. Includes cleaning, priming, repair/replacement of severely damaged metal components, "three course" membrane reinforced patchwork on horizontal seams and protrusions, fastener waterproofing/replacement. Also includes drainage optimization/waterproofing of gutters.

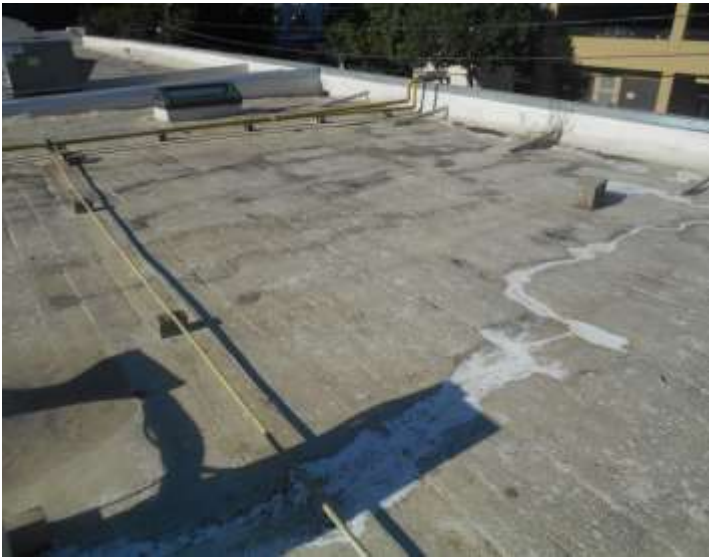
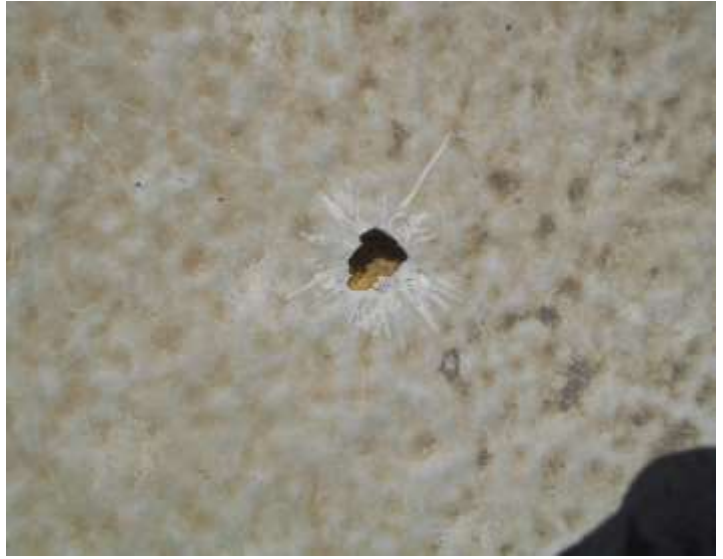
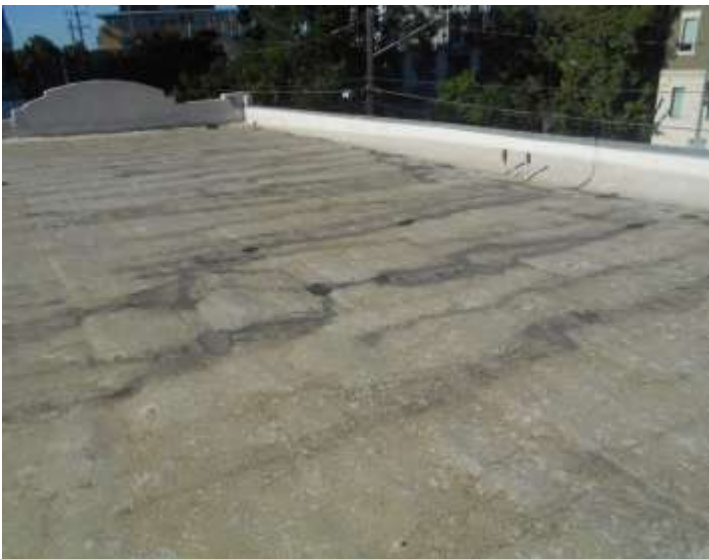
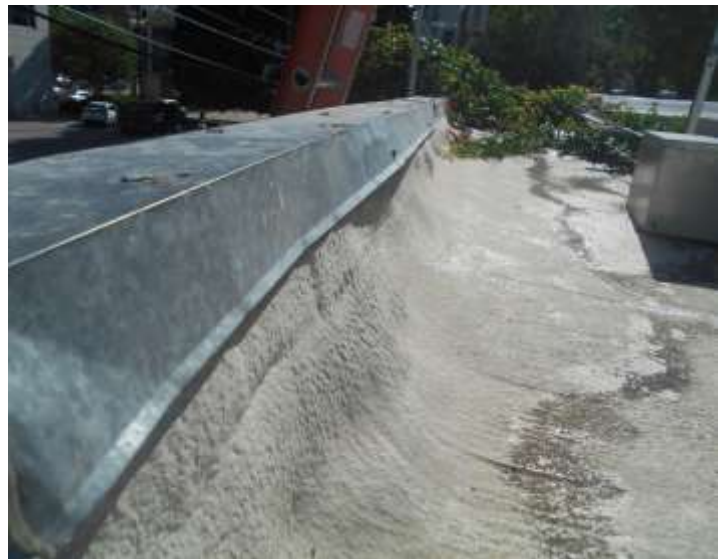
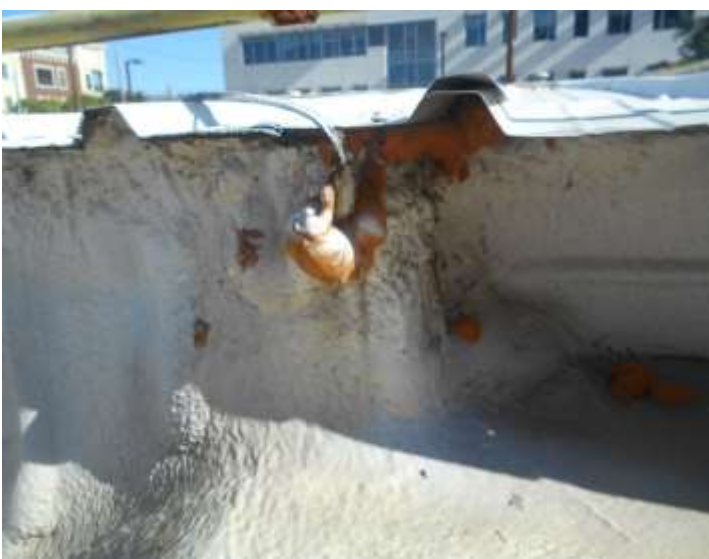
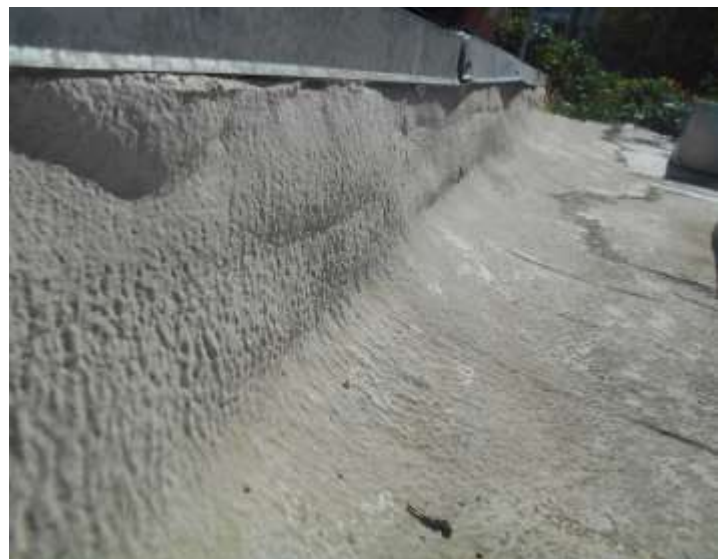
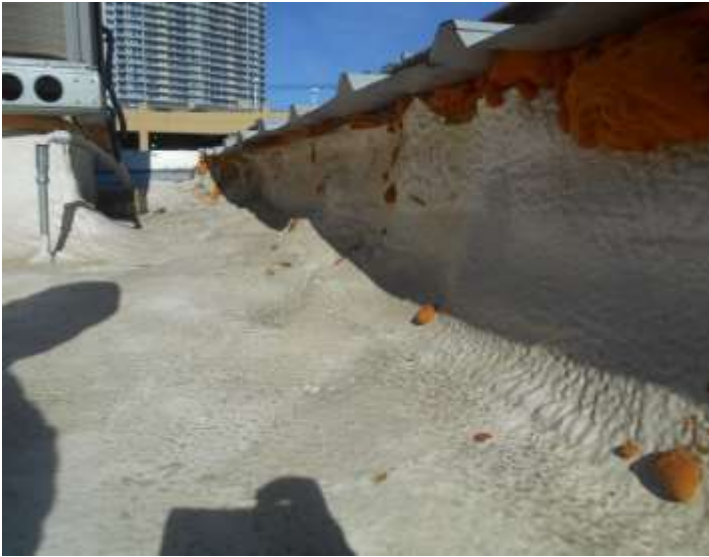
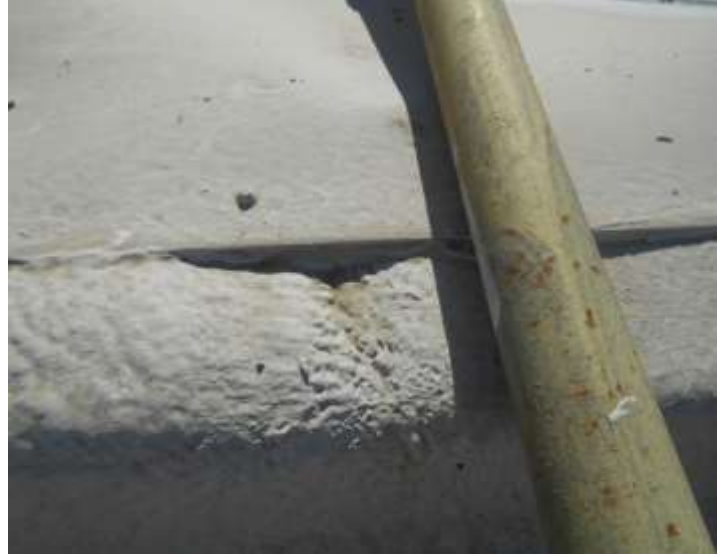
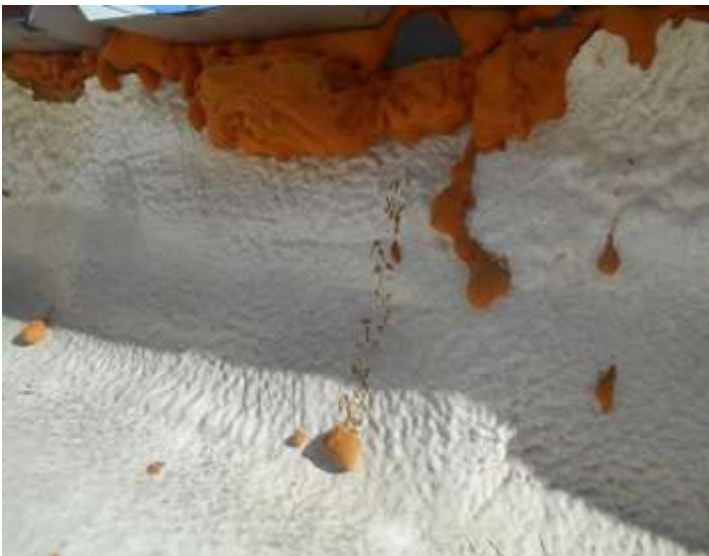
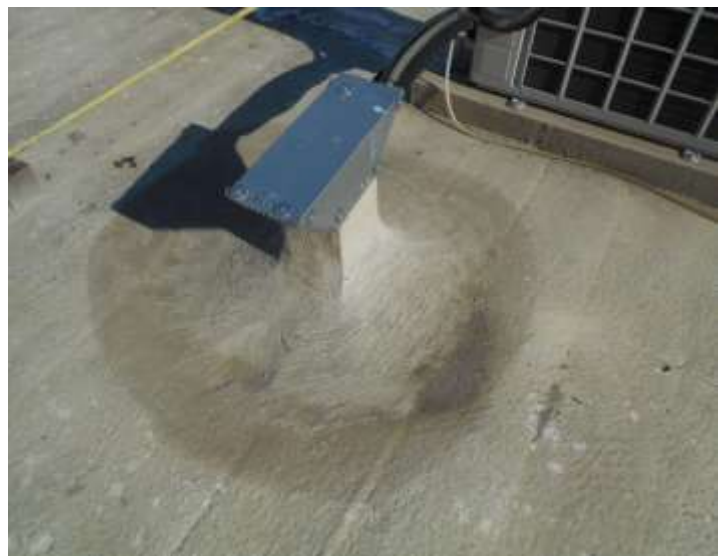
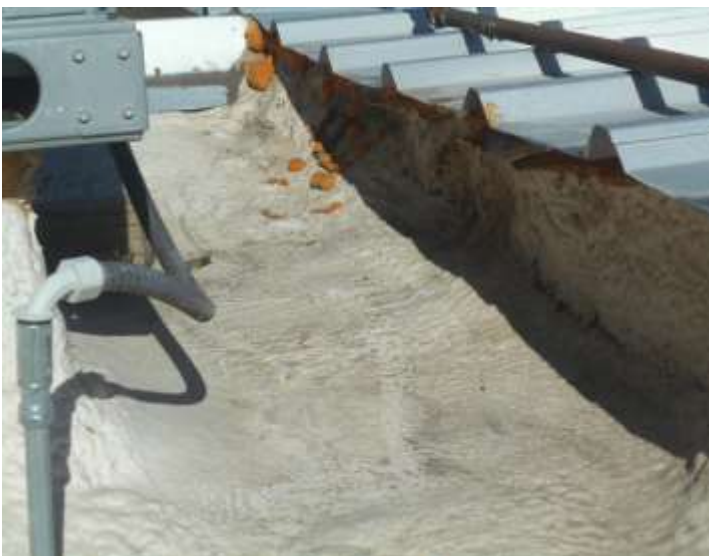
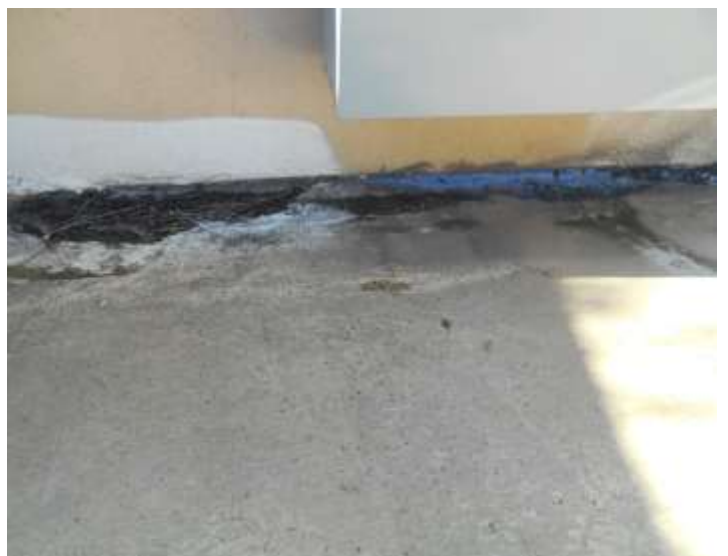
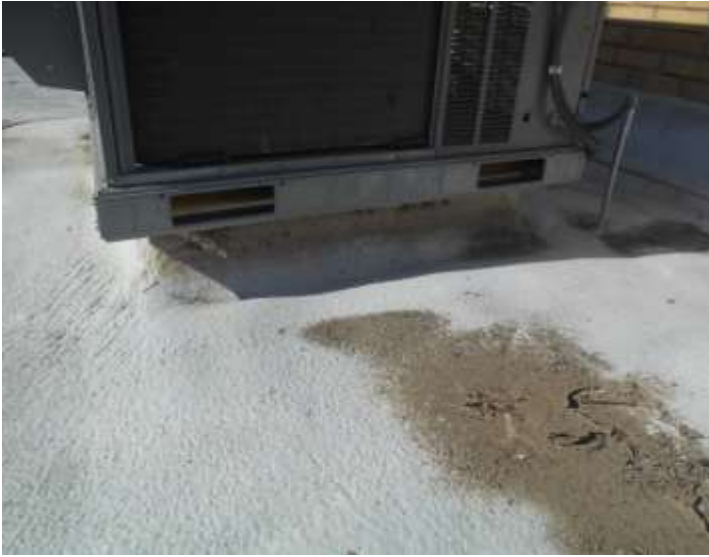
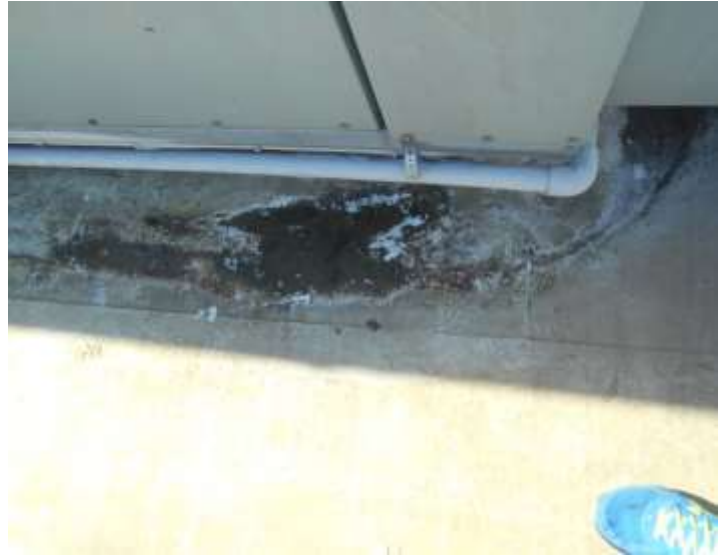
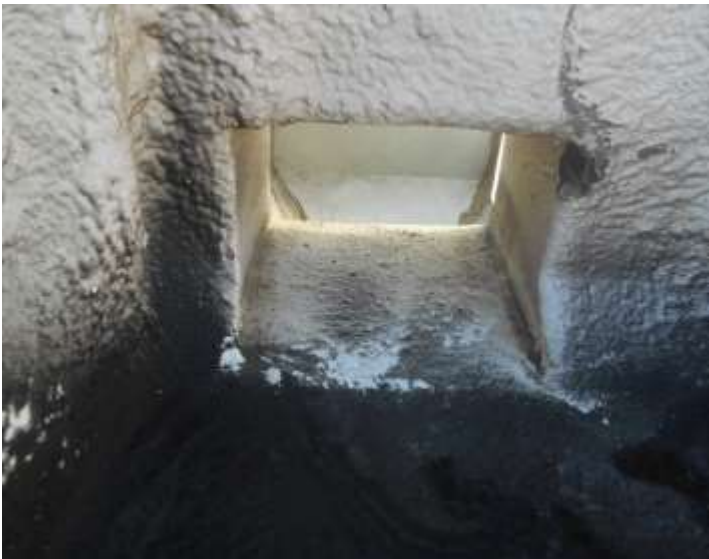
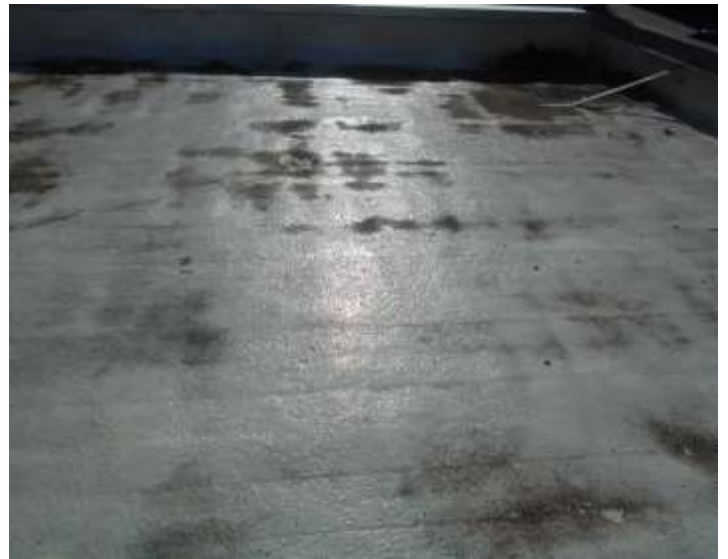
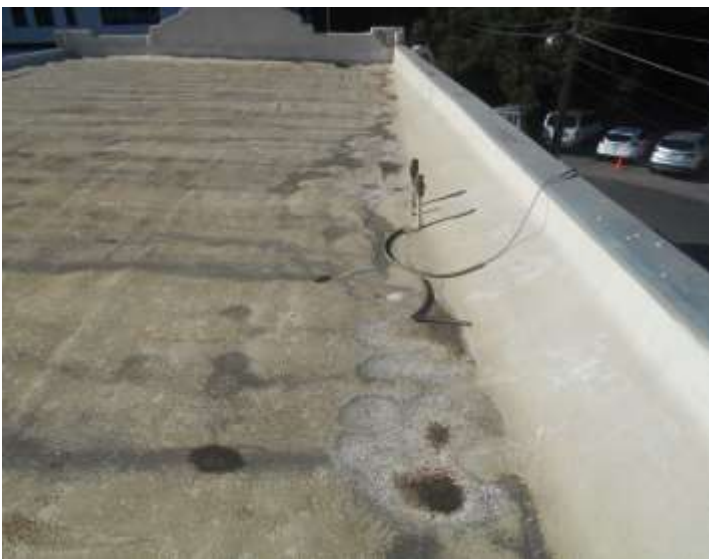
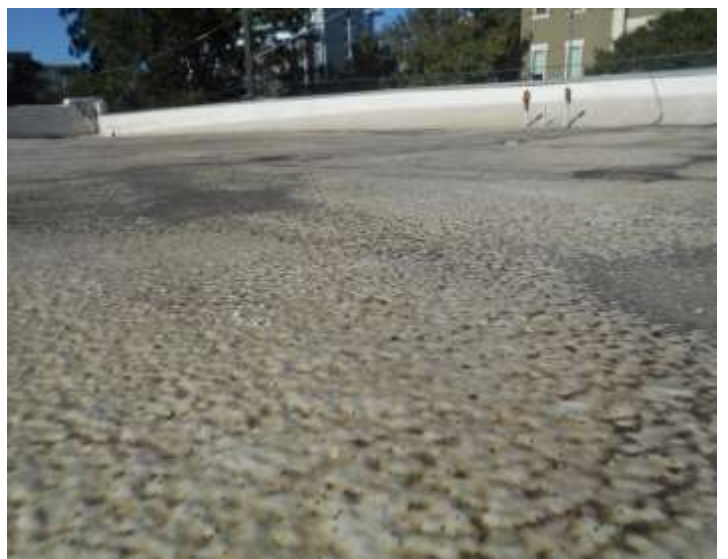
See pictures of deficiencies pages 7-9 - SPF Roof Area

9,500 sq ft of Sprayed Polyurethane Foam (SPF) over aged modified bitumen. The base modified bitumen roof appears structurally sound, but is otherwise in undetermined condition. The SPF overlay was professionally applied including a (required) high quality Urethane roof coating. It appears to be about 3-5 years old. Various chemically incompatible patchwork materials were noted throughout the roof. This is cause for alarm as the materials applied may be initially effective, the net result will be worsened leaks and a more severe deficiency. A full coating of this section is recommended to obtain a full warranty and preventative maintenance program as required per manufactures to maintain NDL warranty. Roof is in Fair overall conditions with several suspect leak areas and poorly maintained sections.

*Prep and patch entire roof. Includes cleaning, priming, repair/replacement of severely damaged metal components, "three course" membrane reinforced patchwork on visible craters, fractures and protrusions.
