Property Inspection Report

JOB # 1653
July 7, 2016

Property Condition Report

Property Developed in: 1986
 Number of Units: 47
 Occupancy: 83%

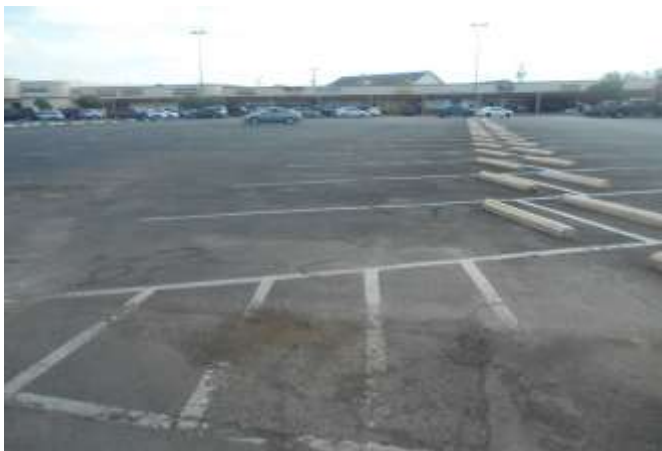
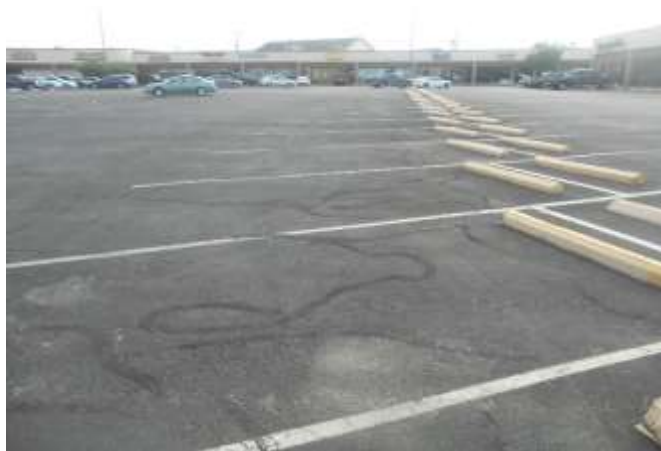
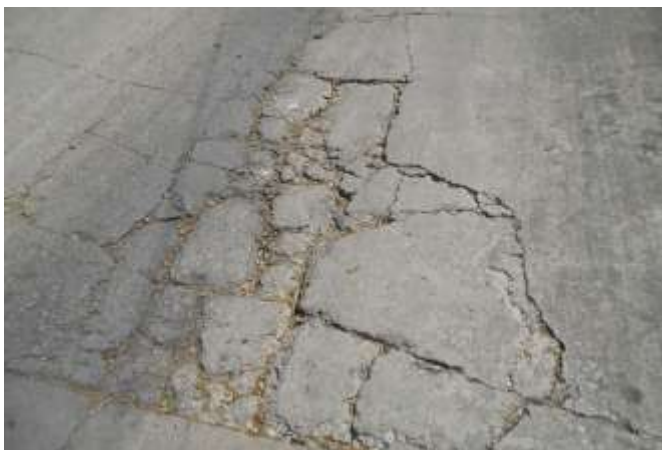
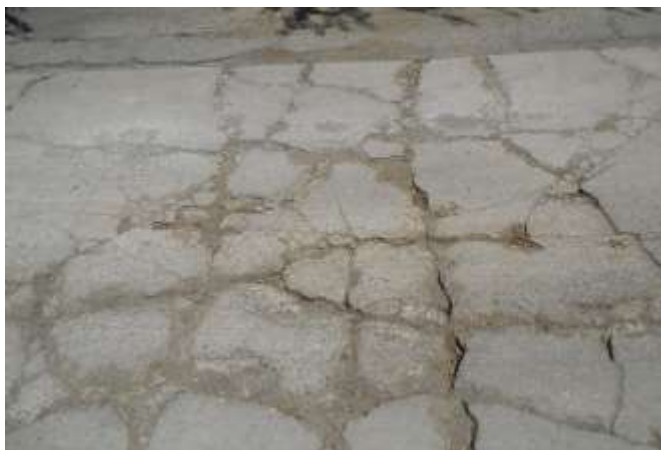
1.3 Paving, Curbing & Parking - The parking areas and drive lanes consist mostly of asphalt paving with concrete curbing and landscape islands throughout. Along the rear of the property near delivery zones, there is a mix of concrete and asphalt paving. The majority of the asphalt paving throughout the front of the property was observed to be of sound structural condition with minimal damage and deterioration. Much of the existing seal coat and striping was observed to be fading and/ or chipping away. Seal coat and striping of parking stalls and curbing is recommended throughout the main parking areas and drive lanes in order to improve the overall curb appeal of the property. Much of the existing asphalt and concrete paving along the rear of the main building was observed to be lightly damaged, but has minimal traffic flow through the area. Existing deterioration throughout the area does not warrant replacement at this time

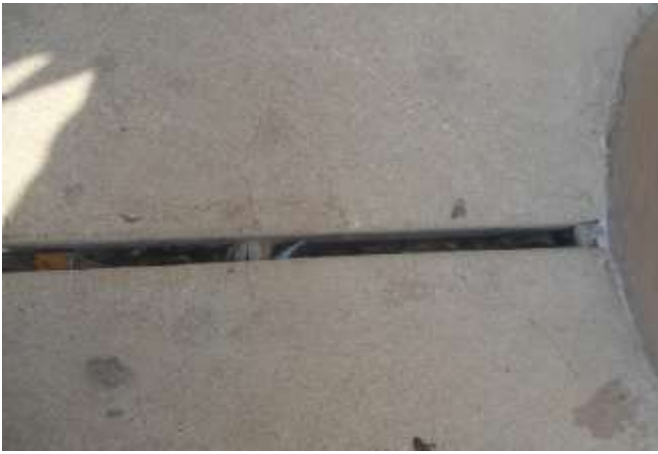
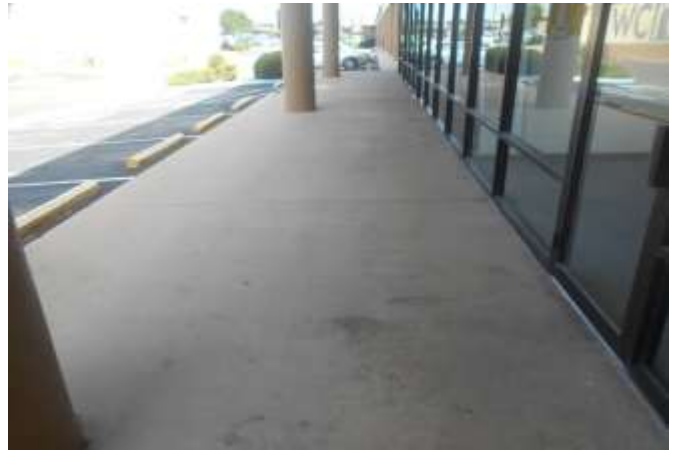
1.4 Flatwork - The concrete walkways throughout are in overall good condition with some trip hazards. In some areas, APAI observed large gaps at walkway expansion joints, creating 1/2" to 3/4" gaps between concrete walkways. APAI recommends installed concrete backer-rod and an elastomeric concrete sealant along these areas in order to remediate the existing trip / fall hazards. APAI also observed light surface deterioration of the concrete walkways in some areas; which will require installing a lightweight, high PSI concrete in order to fill any voids in the walkway. Completing the repairs listed above will help prevent further damages to the existing walkways and increase the overall curb appeal of the property.

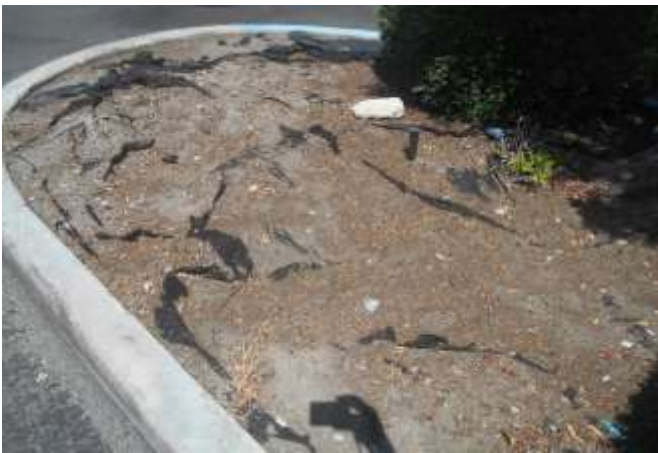
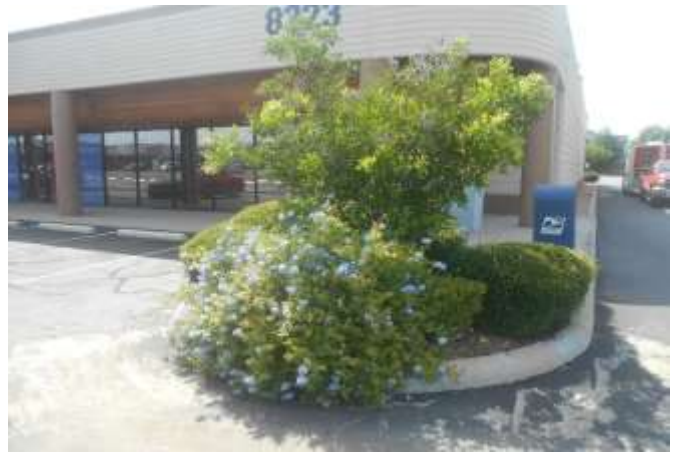
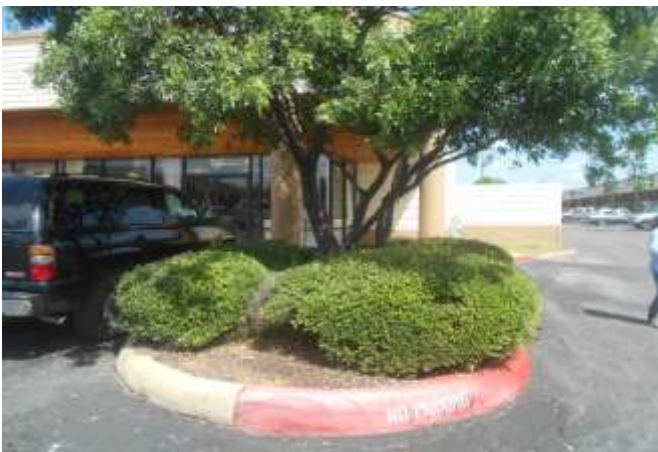
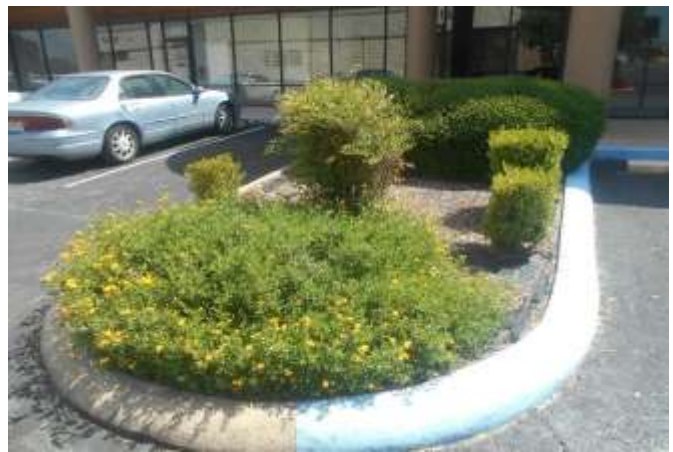
1.5 Landscaping - Landscaping throughout the property was observed to be in good to fair overall condition. APAI observed several landscape beds to be bare, lacking color and ground cover while many of the existing shrubs and trees were overgrown at the time of inspection requiring routine landscape maintenance and clean up. APAI recommends trimming all trees and bushes and placing mulch throughout landscape beds in order to maximize the overall curb aesthetics of the subject property.

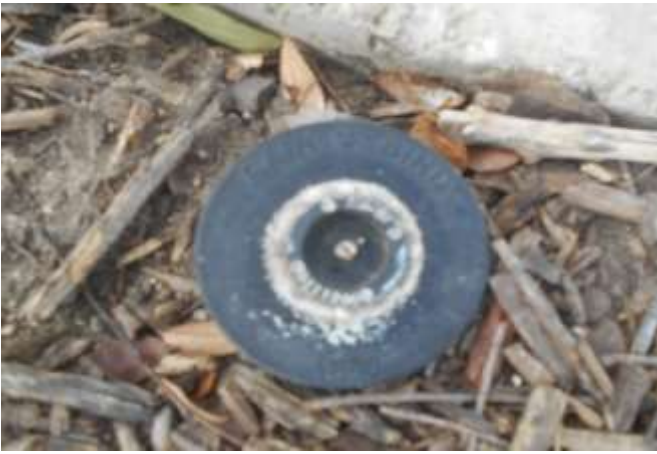
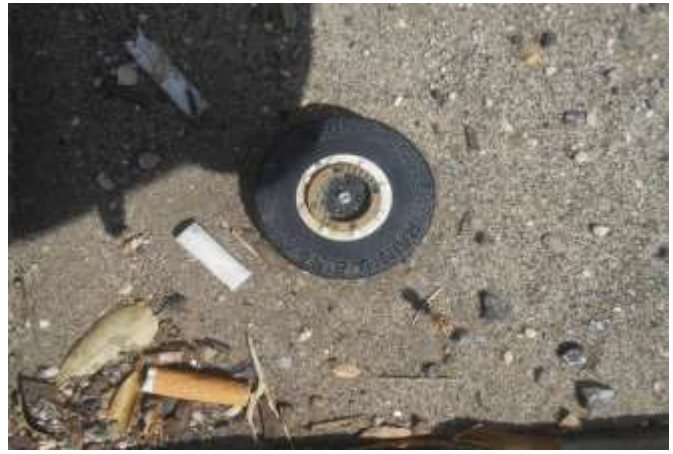
1.5.1 Irrigation - Irrigation sprinkler heads were observed throughout the property but were not engaged at the time of site inspection. The operational condition of the existing irrigation system is unknown to All Pro and should be inspected in order to identify any existing deficiencies.

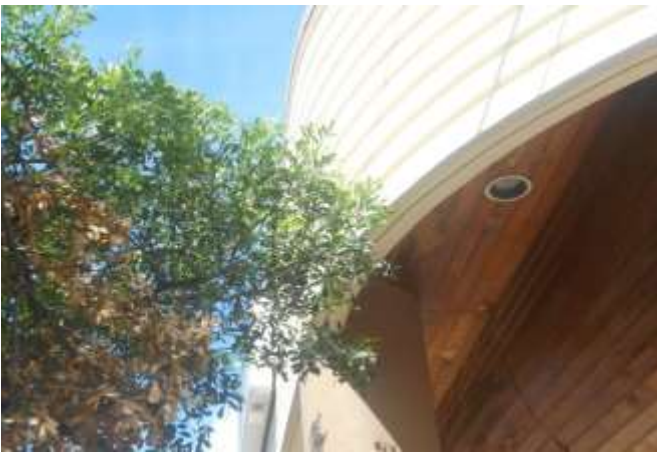
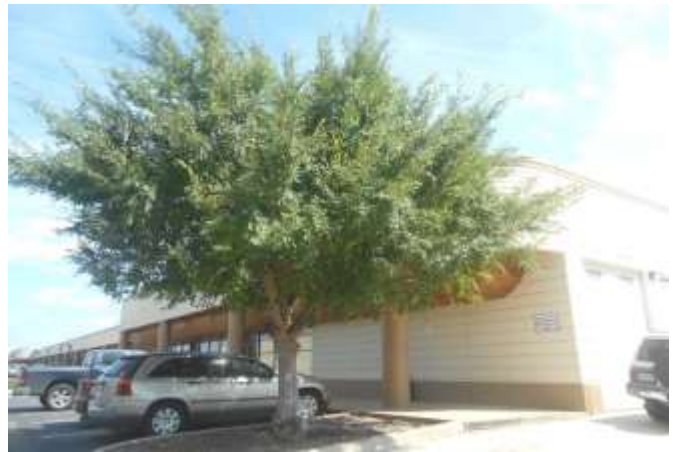
1.5.2 Tree Trimming - All Pro Asset Inspections observed the majority of the existing trees to be properly maintained and not intruding upon parking areas or building finishes. However, several trees along the storefront of the main retail buildings were observed to be overgrown and growing into building finishes. APAI recommends trimming all trees 6' to 8' away from all buildings in order to avoid any possible damages which could be caused by intruding branches and limbs.

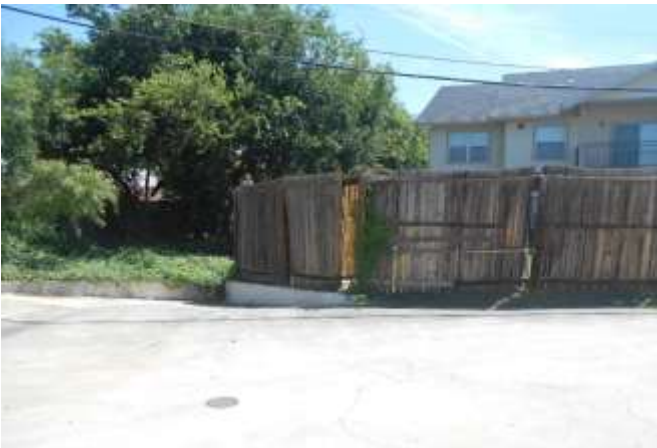
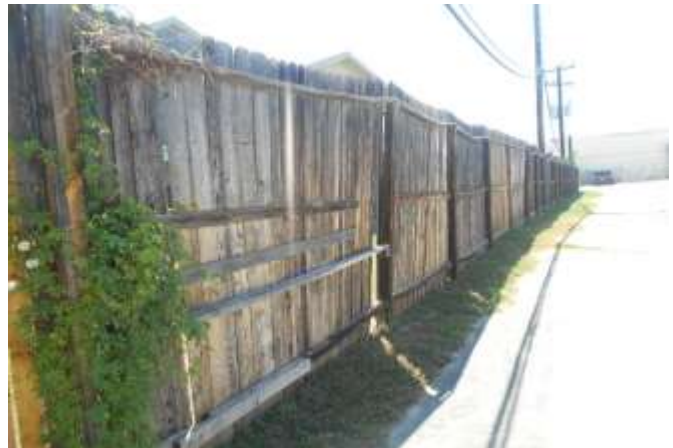
1.8 Fencing - A 6' wood picket privacy fence lines the property along the NW and NE perimeters of the property. It is unknown to APAI if the existing fence belongs to the subject property, or if it belongs to the neighboring sub-division or apartment complex. APAI observed the fence to be in fair to poor overall condition, with many missing pickets and falling fencing identified throughout. If the existing fencing belongs to the property, the perimeter fence requires repair/ replacing the damaged areas in order to increase the overall security of the property.

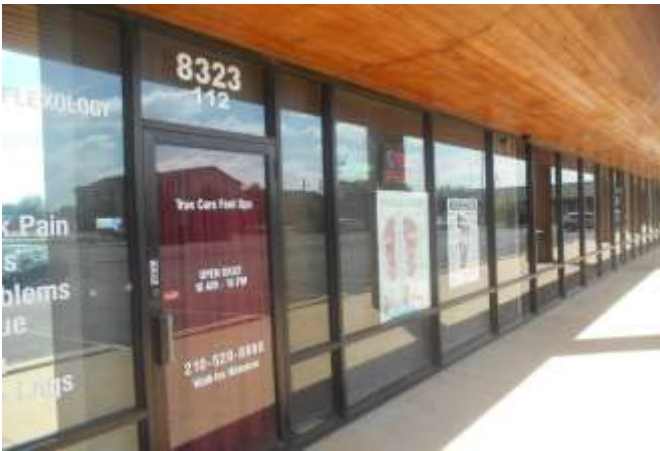
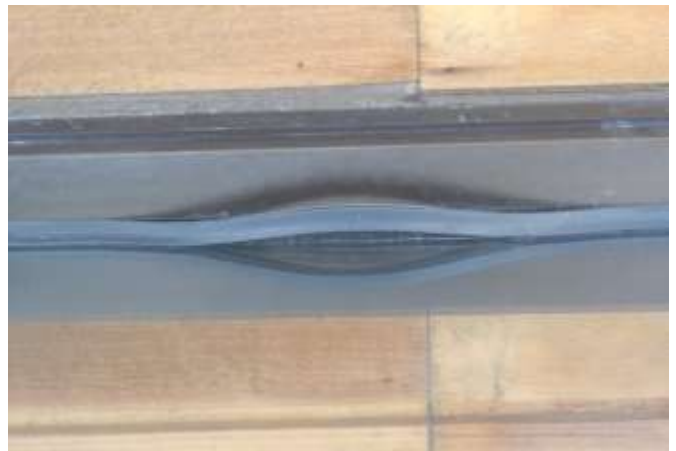
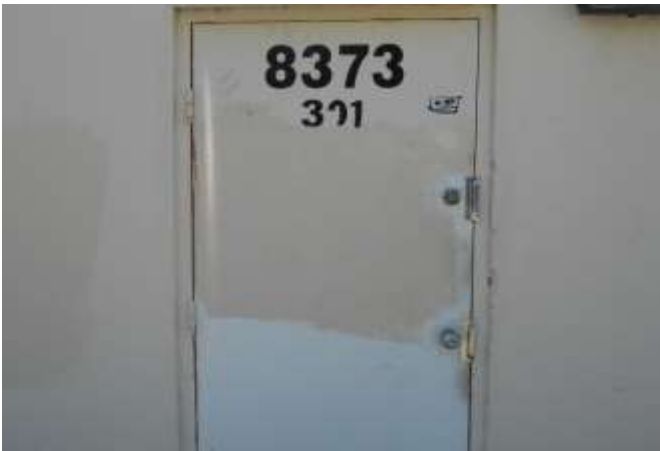
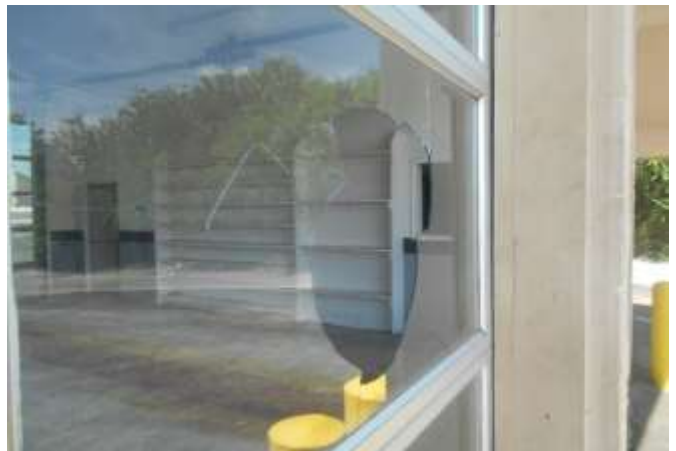
3.4 Windows & Doors - Aluminum framed commercial glazing and storefronts appeared to be in good overall condition. APAI did observe several windows with damaged or missing window beads, which should be replaced in order to minimize potential water intrusion points. The doors along the rear of the main buildings were observed to be hollow core metal slabs with welded metal door jambs. The rear man entry door were observed to be in good condition. Overhead roll up doors are located vehicle service center along the SE wall at building 8333, and appeared to be in proper operating condition. Overhead roll up doors are also located at out parcel building # 1, of which a broken window pane was observed on one of the doors along the north side of the building.

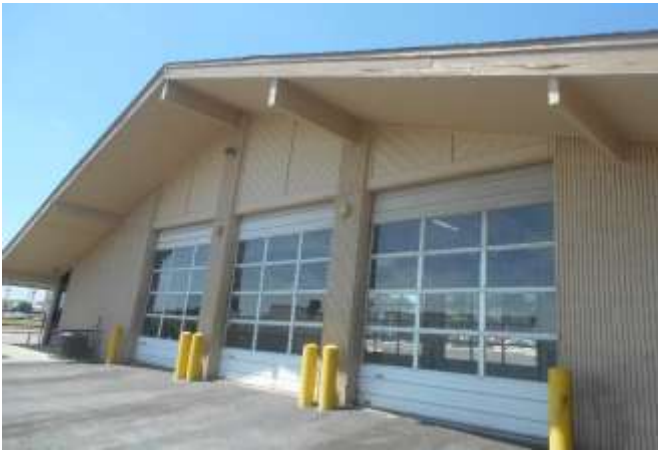
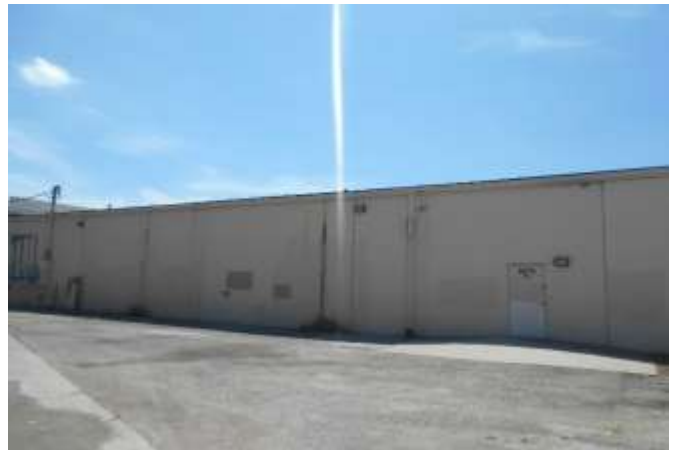
3.7 Exterior Paint (structures, railing, fencing)- The paint along the fronts of the main retail buildings was observed to be in good overall condition, with little to no damaged or stained paint. The existing paint along the rear of the main building was observed to be in fair condition, with many areas of miss-matched paint due to graffiti cover-up, water staining due to leaking / broken gutters and down spouts, and several areas of current graffiti. The paint along out parcel building # 1 was observed to be in fair condition as well. Much of the existing paint along wood finishes is delaminating, and is no longer protecting the wood beneath. All Pro recommends completing a full prep, wash and paint of the rear exterior walls of the main building and all exterior finishes of out parcel # 1.

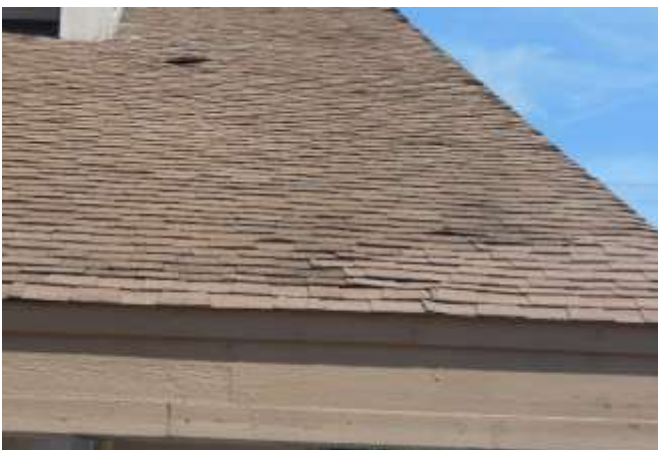
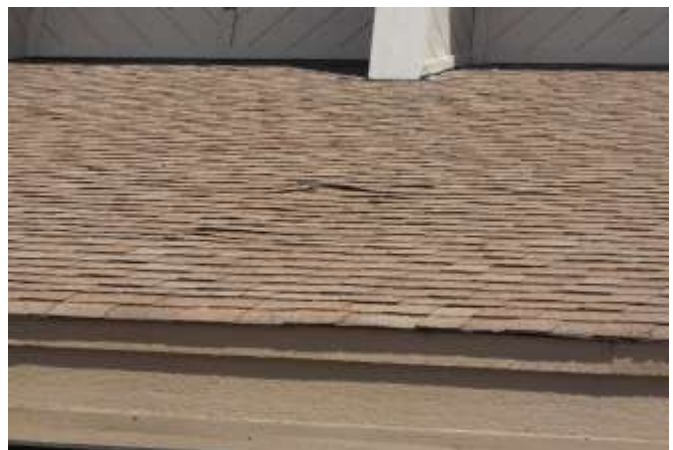
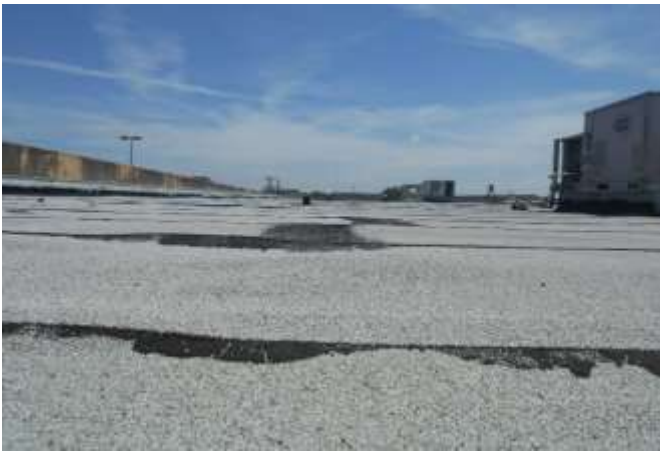
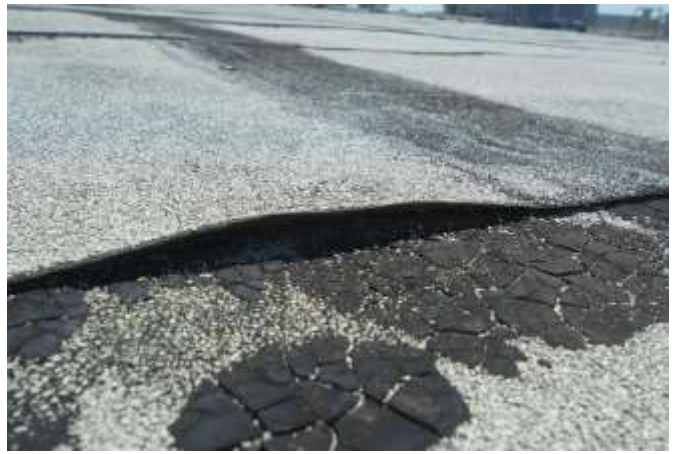
3.8 Roofing - The roofs currently servicing the tenant spaces below along the main retail buildings were observed to be built up asphalt roofs, with tar seams. The roof servicing the 8323 building was observed to be in fair condition. APAI observed many separating seams, along with many air pockets between the asphalt and the substrate. The air pockets indicate signs of prior leaks and / or water intrusion, and must be cut out and patched in order to avoid and interior water damages. With routine maintenance and patchwork, the existing roof system should be serviceable for the next 5 - 6 years. The roof along out parcel building # 1 was observed to be a pitched, 30 year architectural shingle system. APAI observed the roof to be nearing its expected useful service life, and in fair overall condition. APAI observed several areas with lifted shingles, most likely caused by heavy storms within the past couple of months. APAI did not identify any indications of rotted or damaged substrate, nor were any known leaks or issues reported at the time of inspection. As with the 8323 building, routine maintenance and patch work to the existing system should extend the life of the roof for the next 3 - 5 years.

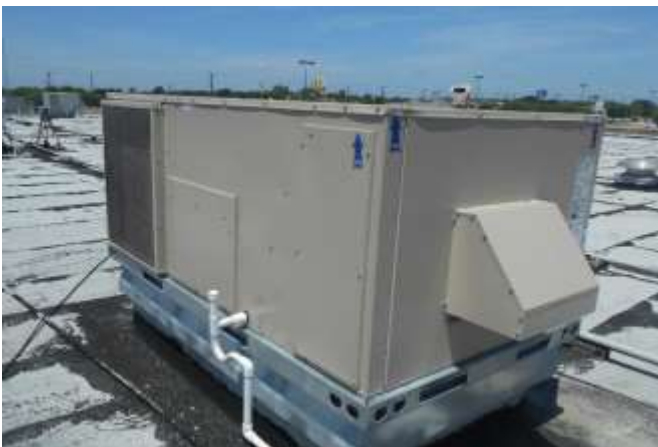
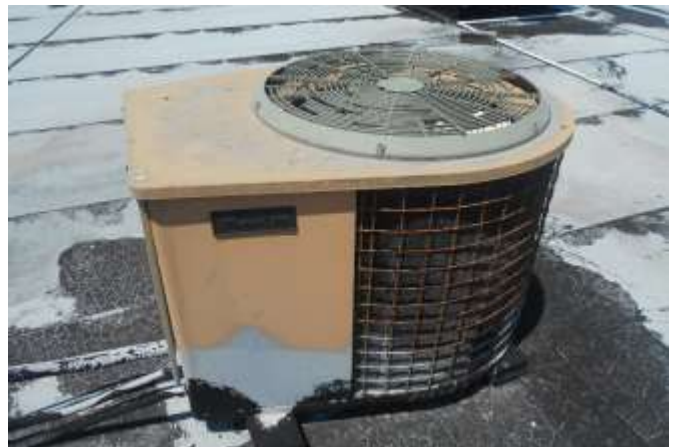
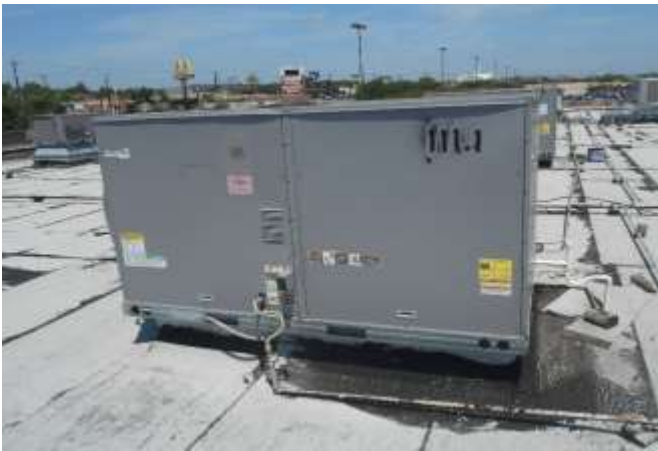
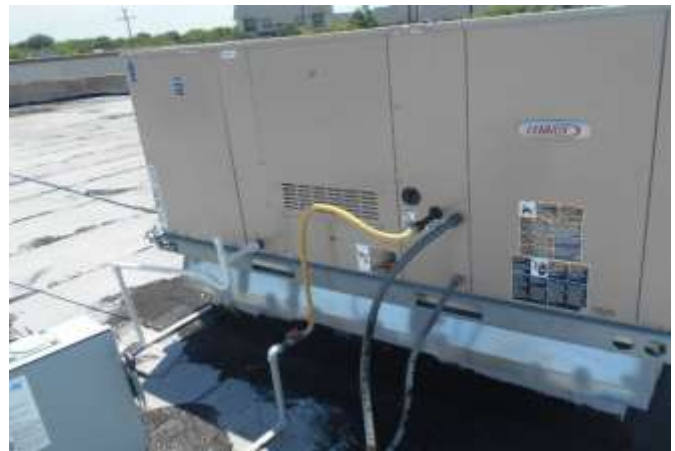
6.1 HVAC Tenant Spaces - The buildings are equipped with several condenser types, to include gas powered RTUs, electric RTUs and split systems. The units were observed to vary in make and age throughout the property. The current operational condition of the HVAC units is unknown to All Pro at this time. APAI recommends conducting an efficiency and operational inspection on all HVAC systems servicing the vacant spaces throughout the property.

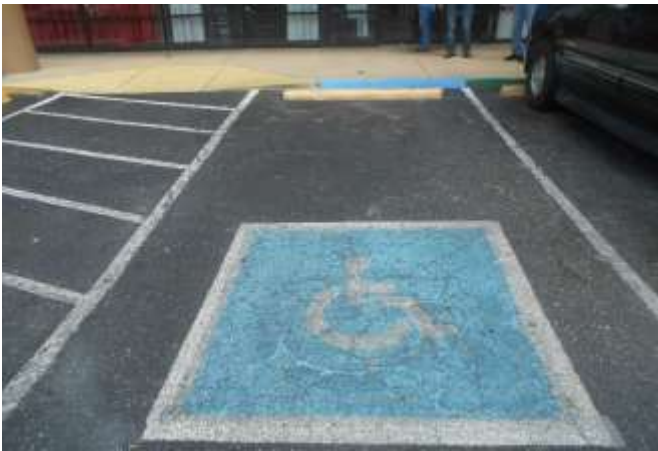
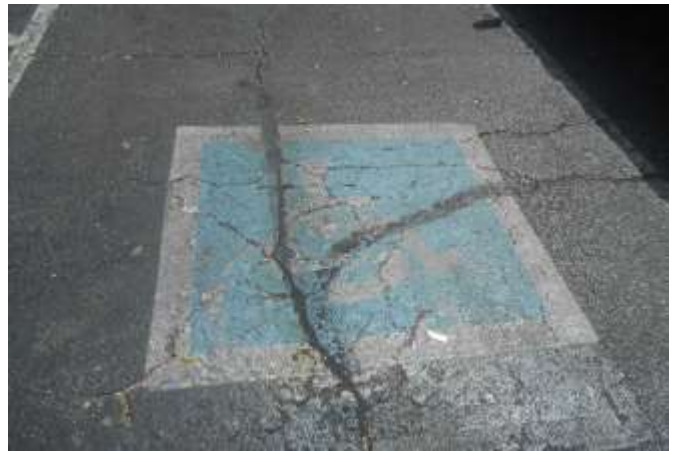
9.1 **Parking - Ingress - Egress**- The parking areas appear to be ADA compliant with ample handicap spaces in close proximity from ingress to walkways. Many of the existing ADA markings are fading and should be re-painted, while one (1) ADA sign and post were observed to be missing along the 8323 building. APAI recommends to replace the missing ADA sign and post in order to properly identify the space.
