Property Inspection Report

JOB # 1653
July 7, 2016

Property Condition Report

Property Developed in: 1986
 Number of Units: 47
 Occupancy: 83%

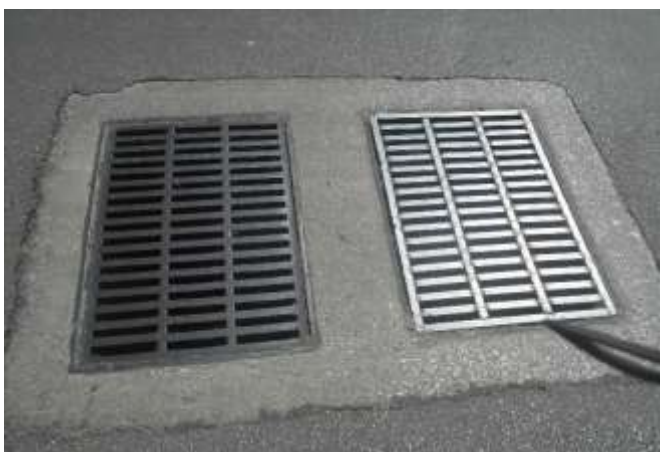
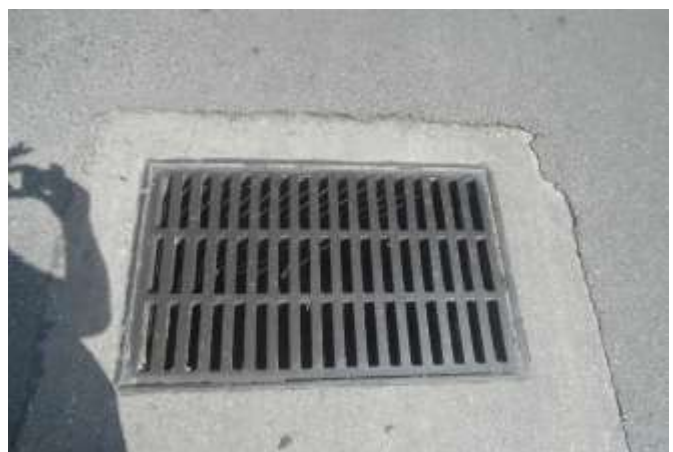
1.3 Paving, Curbing & Parking - The parking areas and drive lanes consist mostly of asphalt paving with concrete curbing and landscape islands throughout. Along the rear of the property near delivery zones, there is a mix of concrete and asphalt paving. The majority of the asphalt paving throughout the front of the property was observed to be of sound structural condition with minimal damage and deterioration. Much of the existing seal coat and striping was observed to be fading and/ or chipping away. Seal coat and striping of parking stalls and curbing is recommended throughout the main parking areas and drive lanes in order to improve the overall curb appeal of the property. Much of the existing asphalt and concrete paving along the rear of the main building was observed to be lightly damaged, but has minimal traffic flow through the area. Existing deterioration throughout the area does not warrant replacement at this time

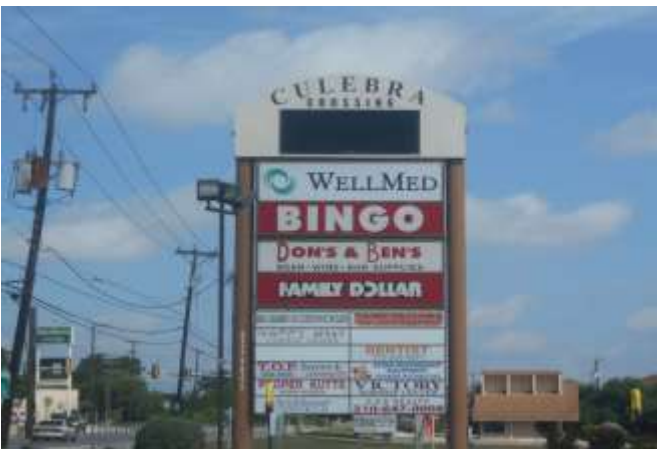
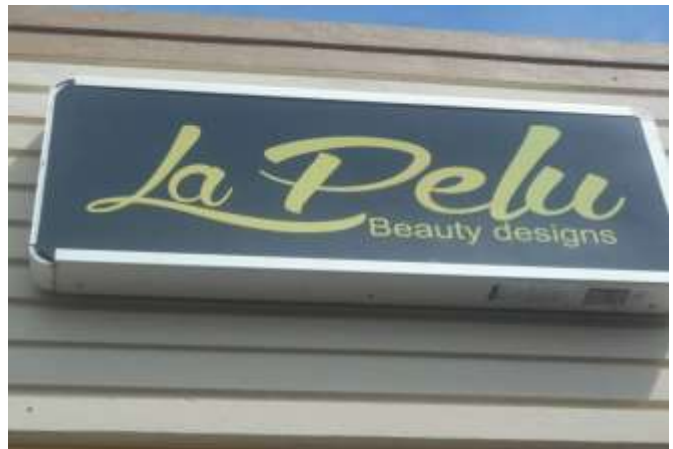
1.6 Signage - The property is currently equipped with three (3) marquis signs, which identify the plaza and its tenants, all of which are located along Culebra Road at property entrances. The marquis signs were observed to be in good condition with no deficiencies identified. Building mounted signs are located along storefronts in order to identify individual tenant spaces. APAI assumes individual tenants are responsible for maintenance and up keep of their own signage. No action is required.

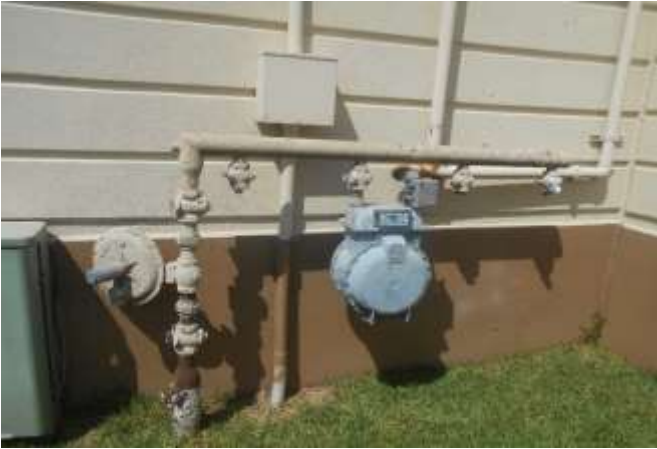
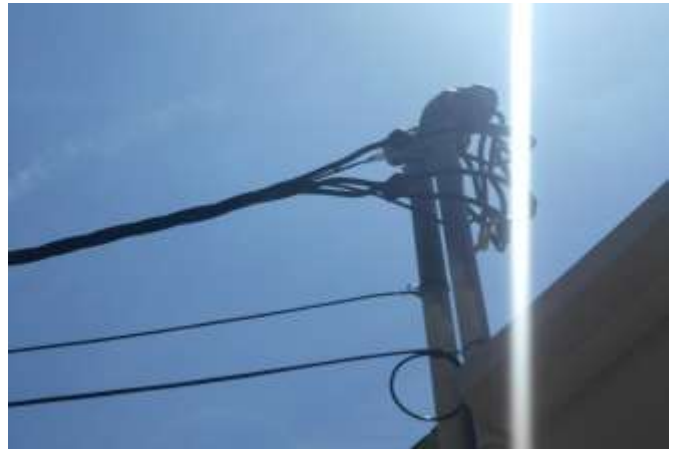
1.7 Utilities - Utilities consist of water, sewer, gas and overhead electric. APAI did not observe any issues indicating faulty or damaged utilities. No action is required.

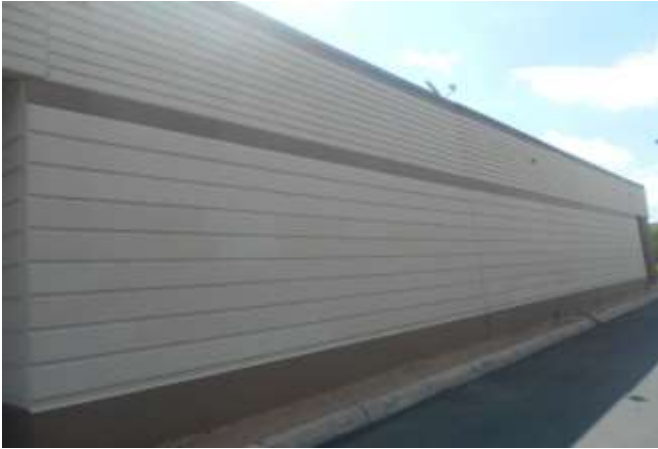
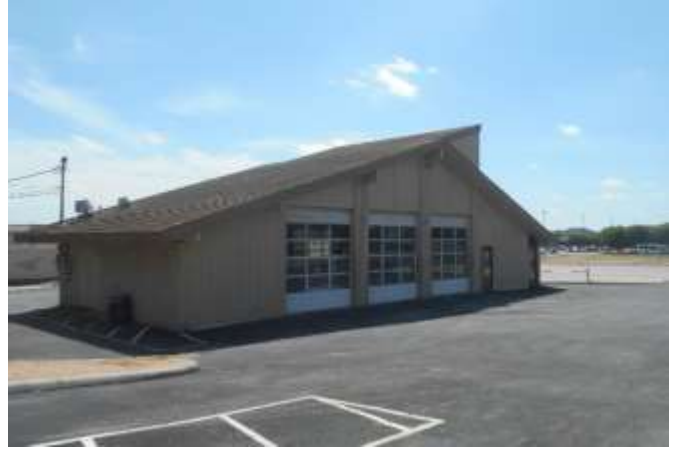
- 3.1 Foundation** - The foundation was observed to be a monolithic concrete slab on grade. All Pro observed the foundations throughout to be in stable condition with no indications of settlement along exterior building finishes. No action is required at this time.
- 3.2 Building Frame** - APAI observed the building frame of the two (2) main retail buildings to consist of concrete tilt-up walls. The interior building frame, load bearing columns and walls, and roof supports are unknown to All Pro at this time. The building frame along the out parcel buildings are assumed to be conventional wood frame, with wood beams supporting the load

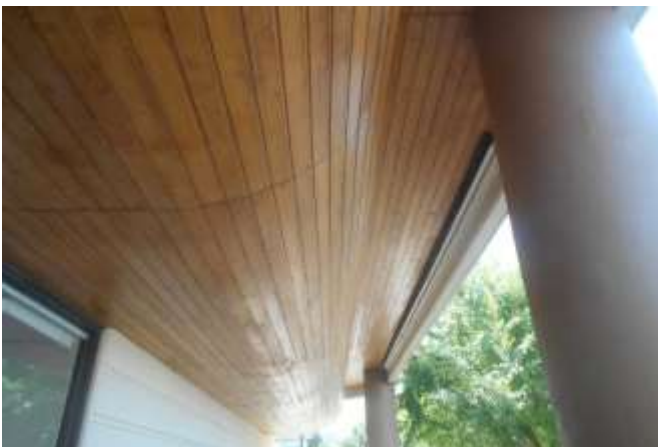
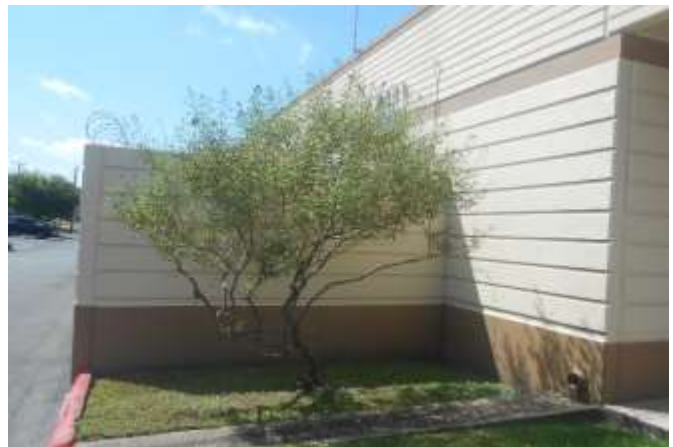
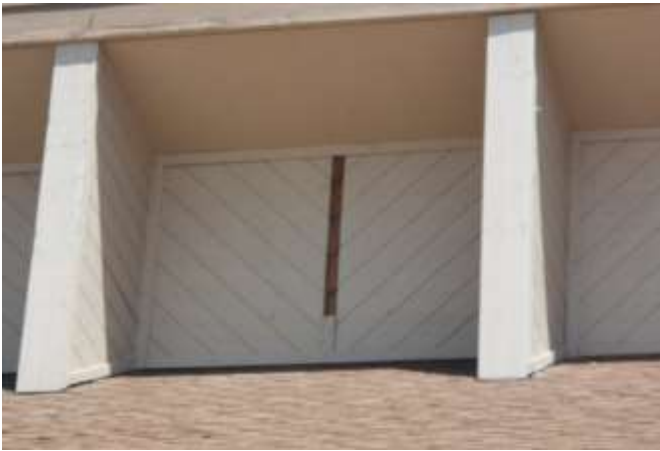
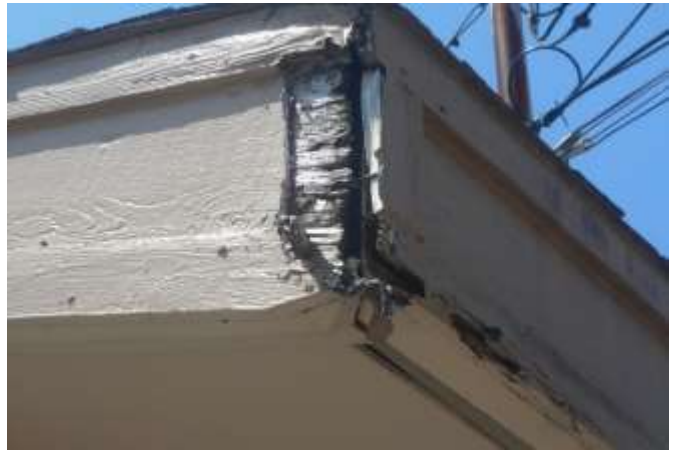
- 3.3 Walls** - Exterior walls along the main retail buildings consist of painted, pre-cast concrete panels, along with tongue-and-groove wood soffit along the storefront overhang. The storefront overhangs are designed with a barrel roof to enhance the overall aesthetics of the property. Aluminum framed storefront windows and doors line the front. APAI observed a small portion of the existing wood soffit to be damaged. It appeared that there was a roof leak in the area, and it is unknown to APAI if the leak is current or if it has been repaired. All Pro also observed much of the wood soffit to be dull and fading, indicating that the protective clear coat is delaminated. APAI recommends to prep the wood finishes, and apply a coat of water sealant clear coat along the storefront overhang soffits. The exterior finishes along out parcel building # 1 consist of painted split-faced concrete panels, 8" cedar lap siding, along with 1" x 4" accent trim at windows and corners, and 2" x 12" fascia. APAI observed much of the existing wood finishes, to include siding, trim and fascia, to be damaged or rotted. Due to the extent of the existing damage, the rotted / damaged wood finishes will need to be removed and replaced with new. Out parcel building # 2 consists of corrugated metal exterior finishes. All pro did not observe any rusted or damaged panels requiring replacement. Out parcel building # 3 exterior finishes consist of brick veneer, with 1 x 8 fascia board. APAI did not observe any exterior damages along the building.

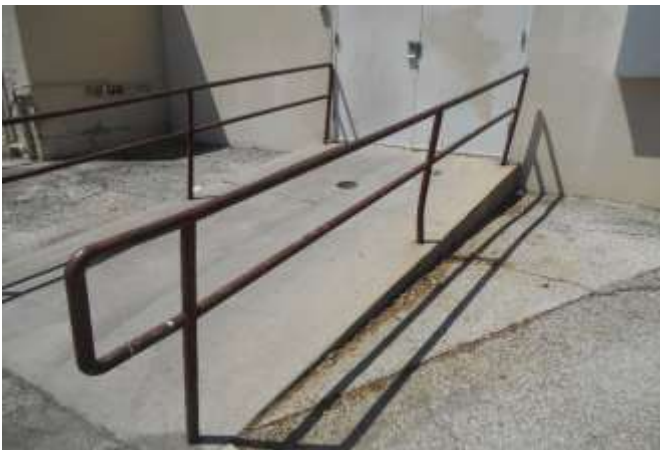
3.8 Hand Railings - Hand railings are utilized at the loading ramp along the rear of the main retail building. The railings were observed to be in good overall condition, with no deficiencies identified.

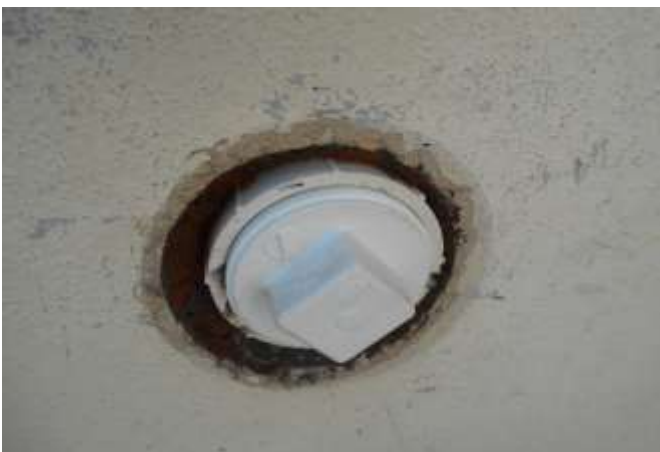
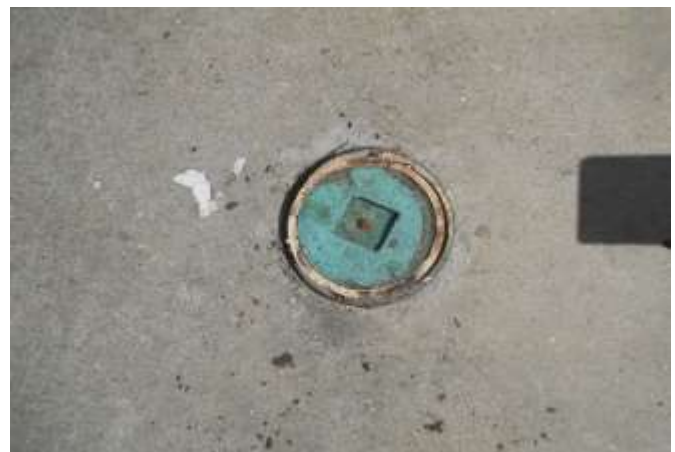
4.2 Sanitary & Grey Water Drain Lines - APAI observed the existing sanitary plumbing clean-outs to be PVC, but was unable to observe interior drain lines.

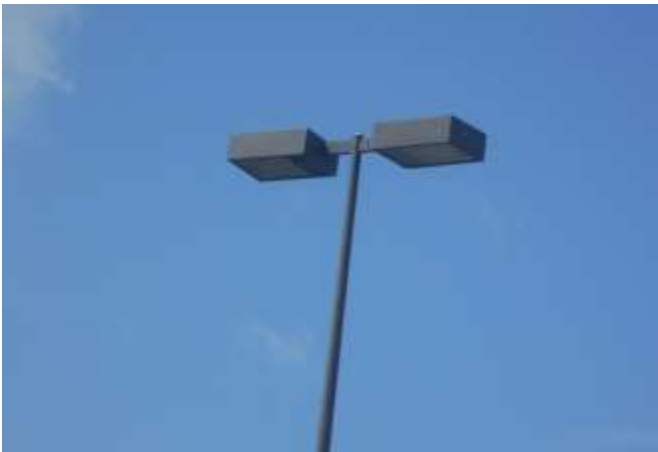
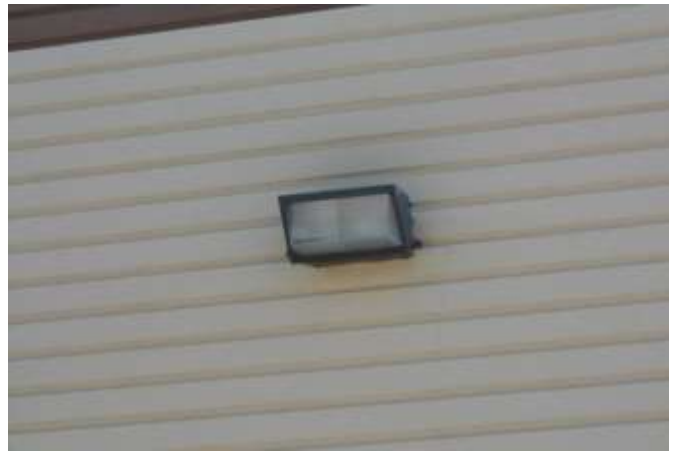
5.4 Security Lighting- Security lighting consists of pole mounted lights in the parking lot, wall mounted security lights along the rear of buildings, and 8' T-12 fluorescent fixtures along the storefront overhang soffits. Security lighting appeared to be adequate throughout the property.

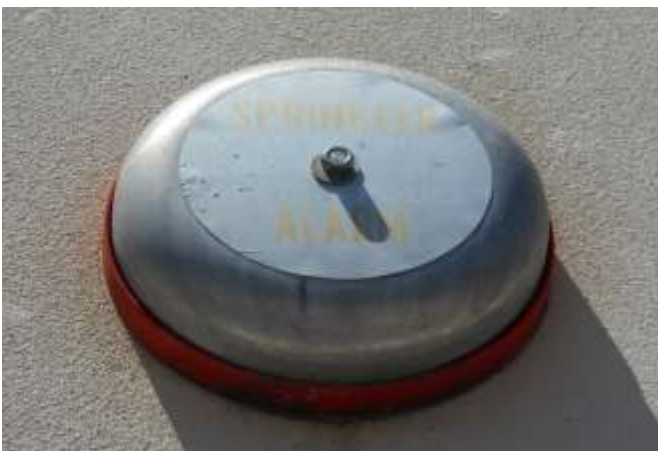
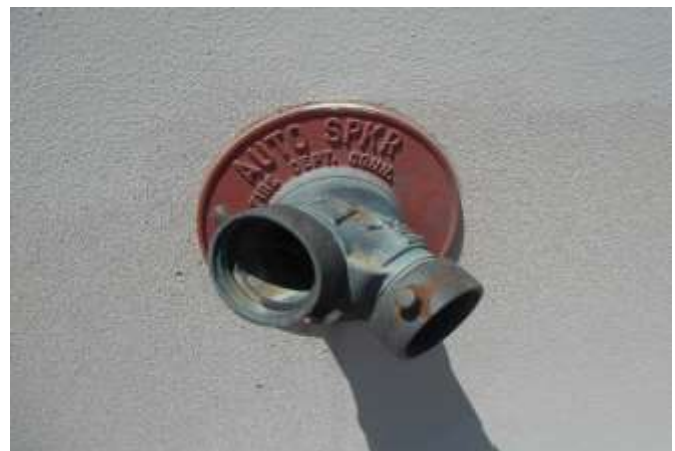
8.2 **Fire Suppression** - The fire suppression system currently servicing the property is unknown to All Pro due to lack of access to mechanical rooms and interior spaces. APAI did observe sprinkler alarms located along the exterior building finishes.
